Annual presentation to Board of Oil, Gas & Mining

Rio Tinto Kennecott

March 28, 2018

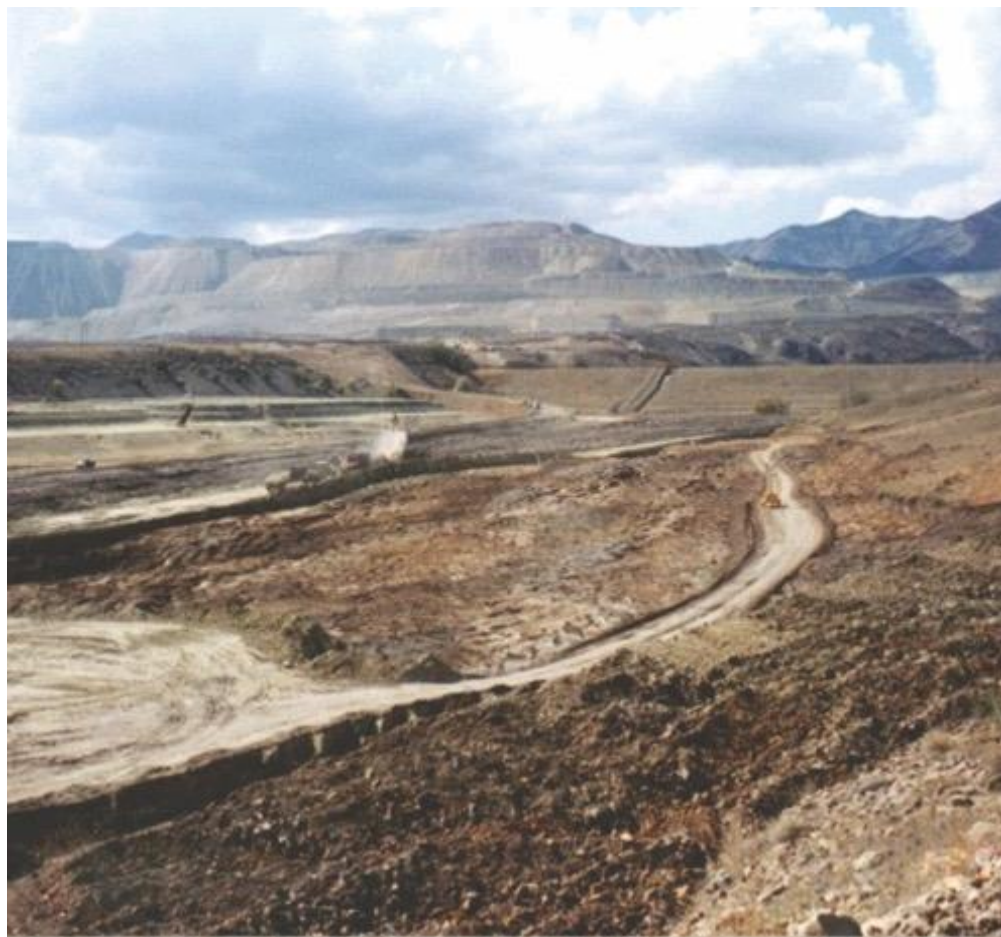
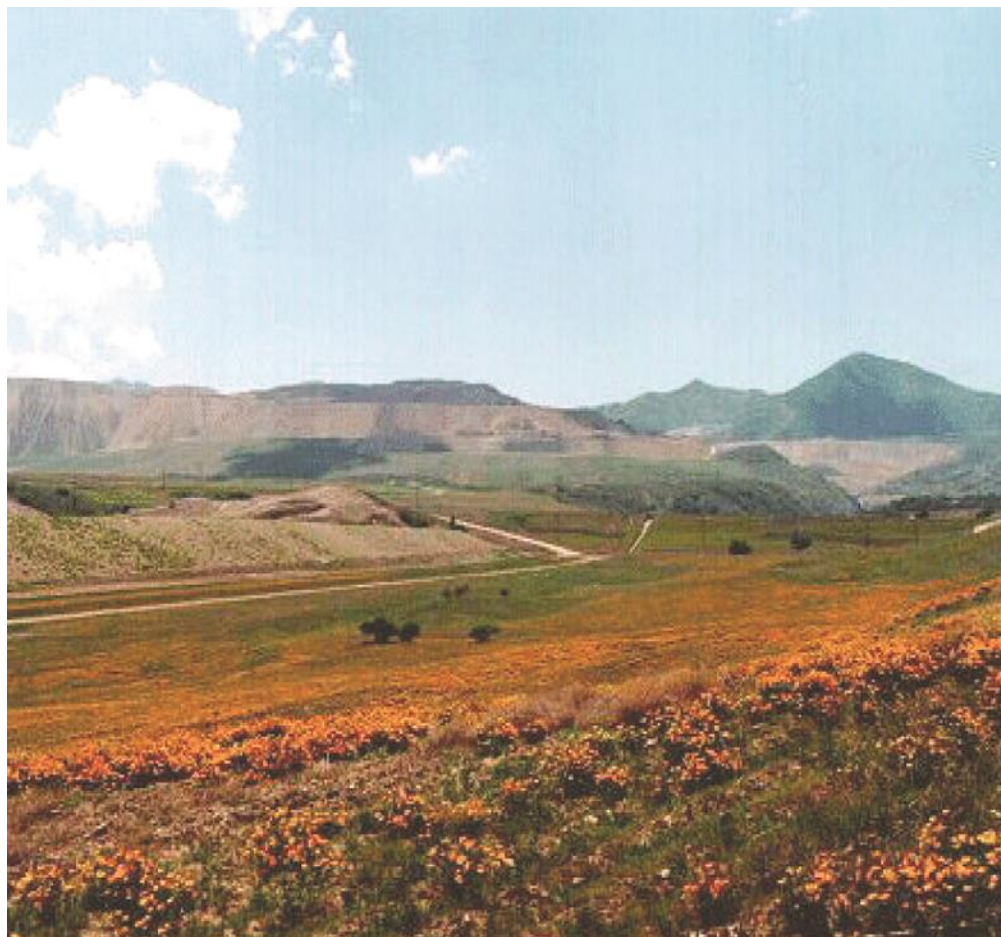
Bingham Creek Tailings

390 acres
reclaimed

1992-1994

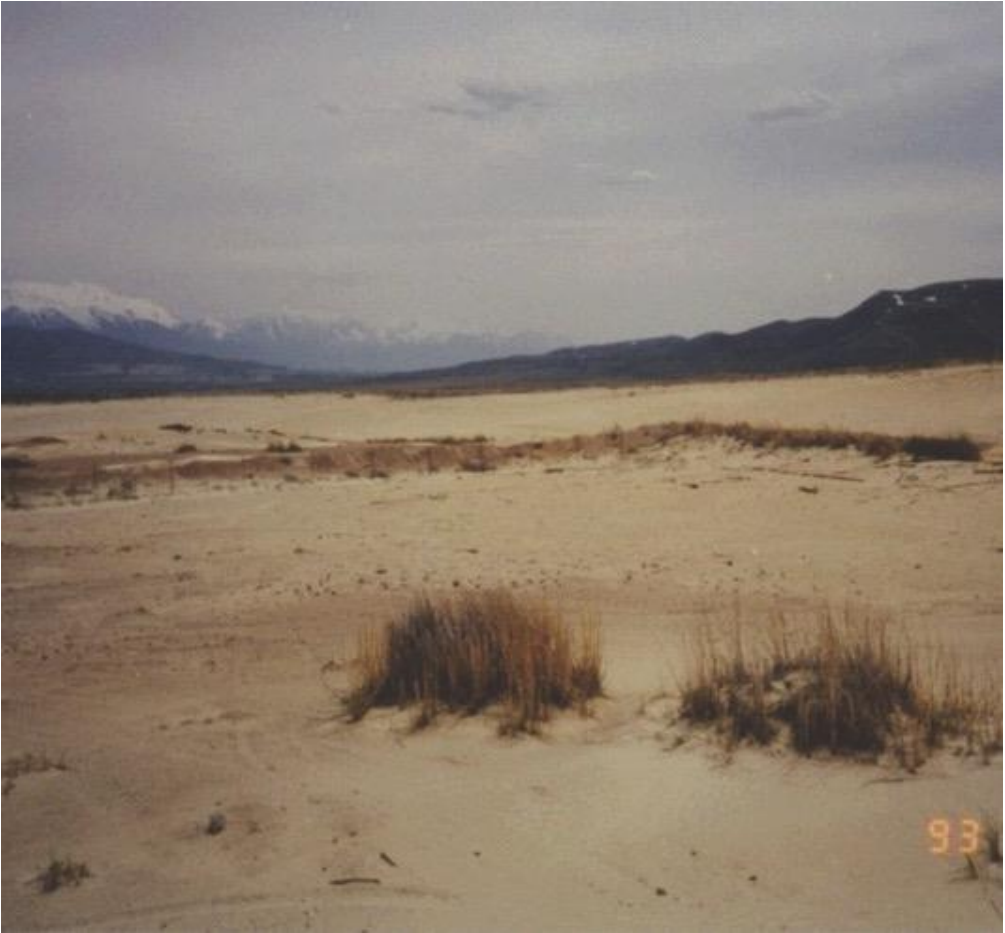
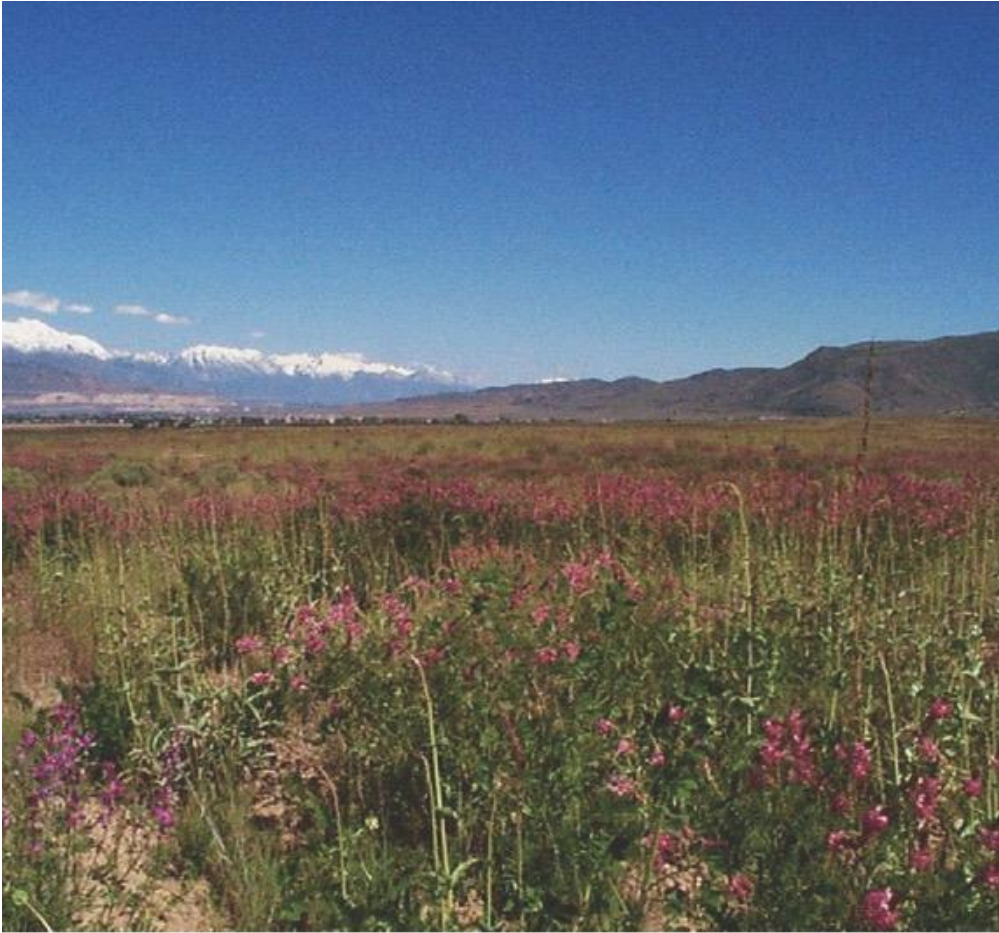
Lark Tailings and Waste Rock

475 acres reclaimed

Removed 2 million tons waste rock

1992-1994

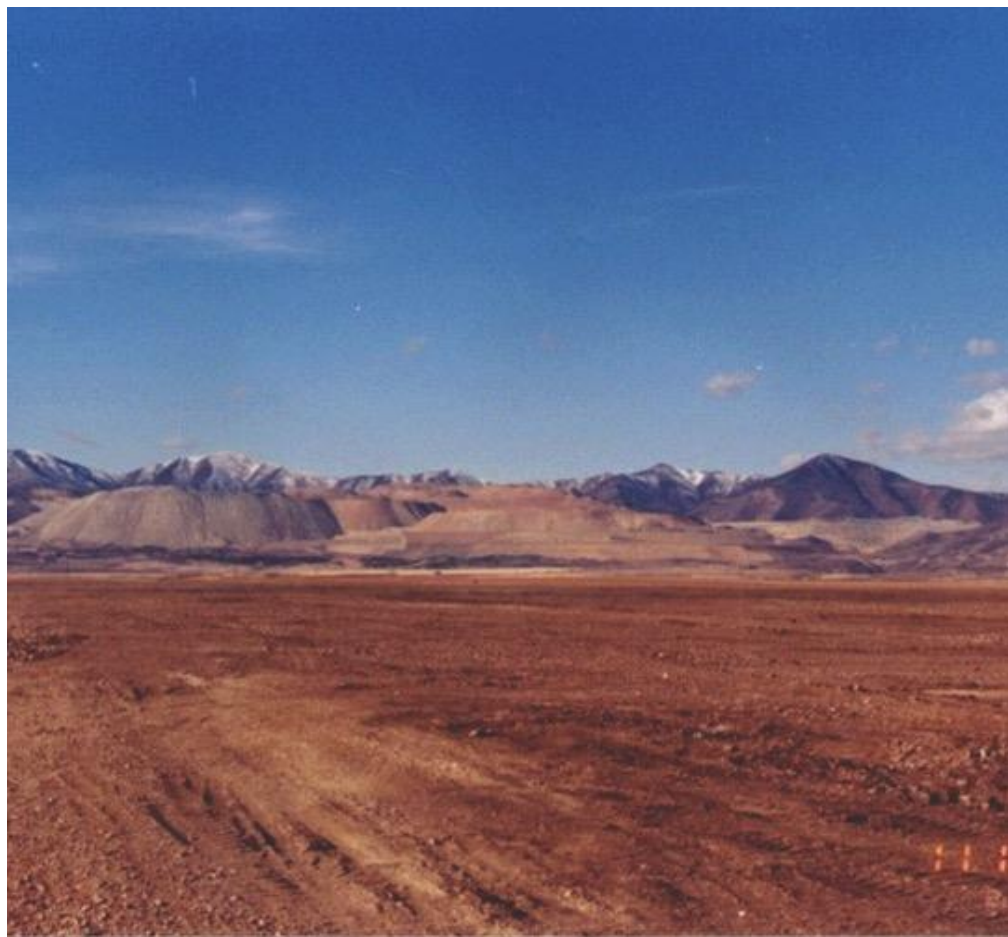
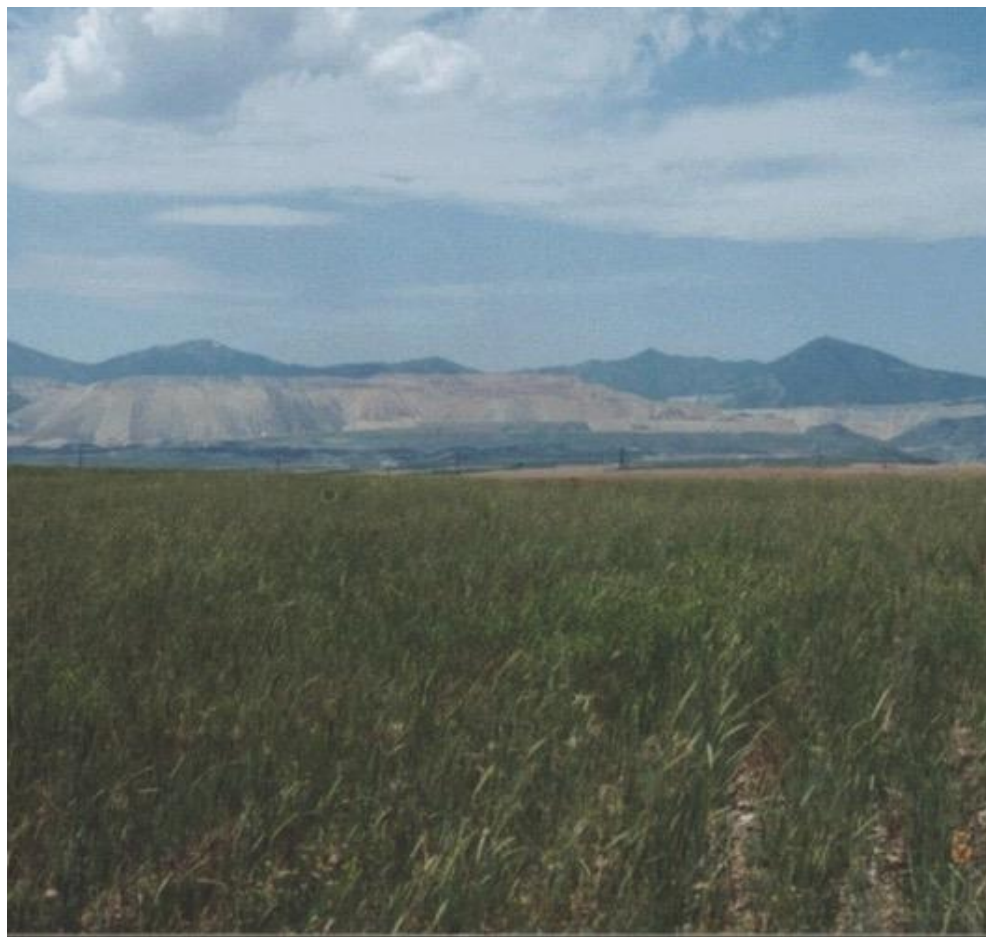
South Jordan Evaporation Ponds

575 acres
reclaimed

1994

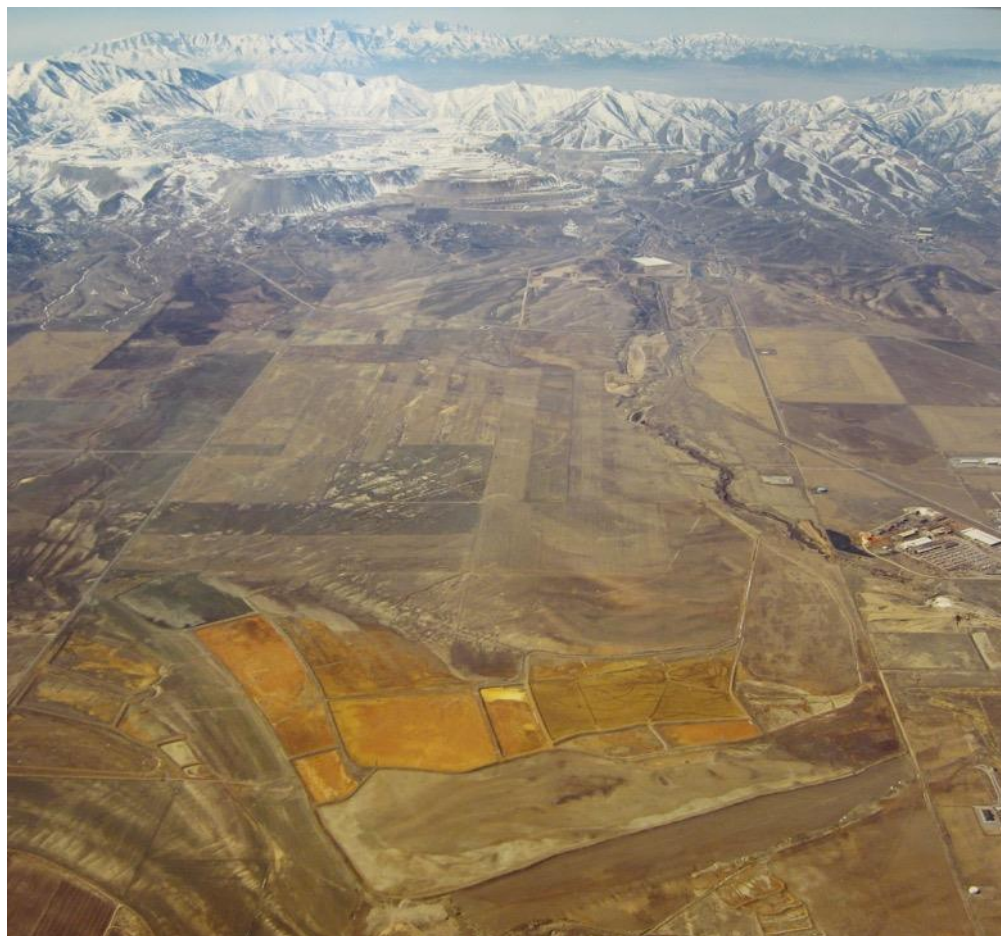
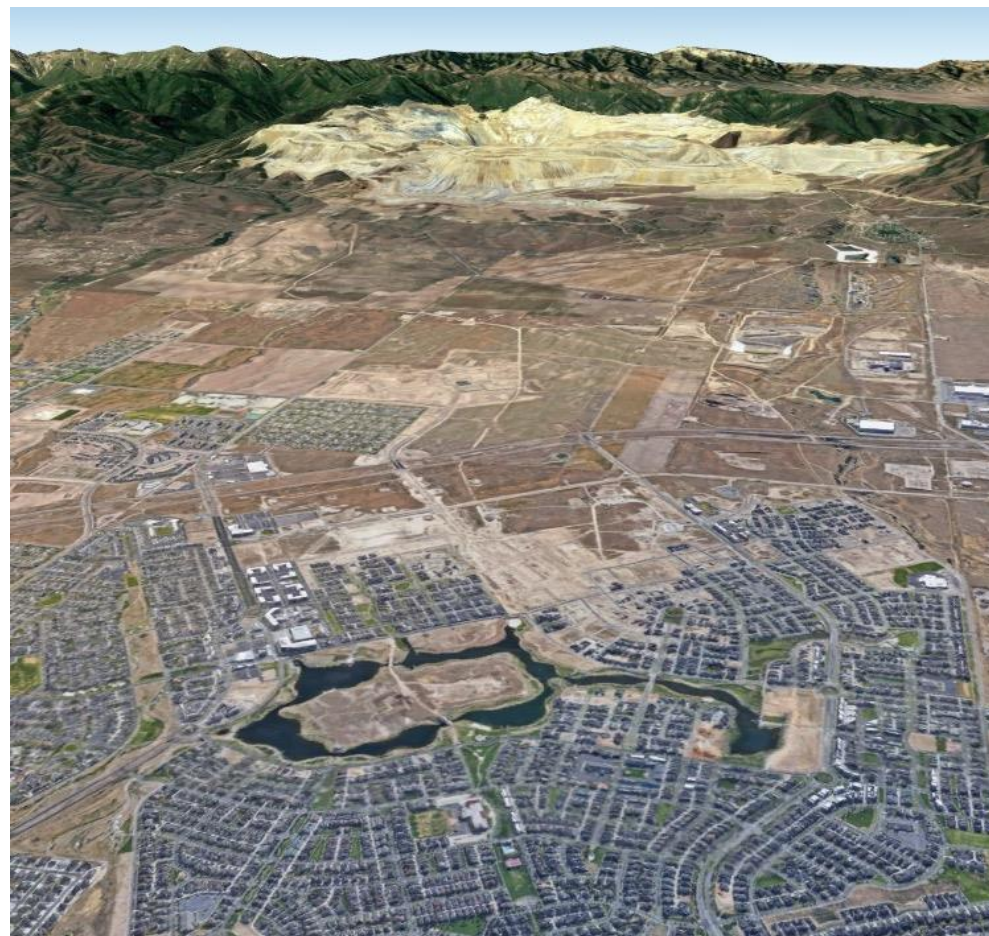
South Jordan Evaporation Ponds (Continued)

200 acres
reclaimed

2003-2009: Bastian Sink, Bastian Ditch, Rail Cleanup

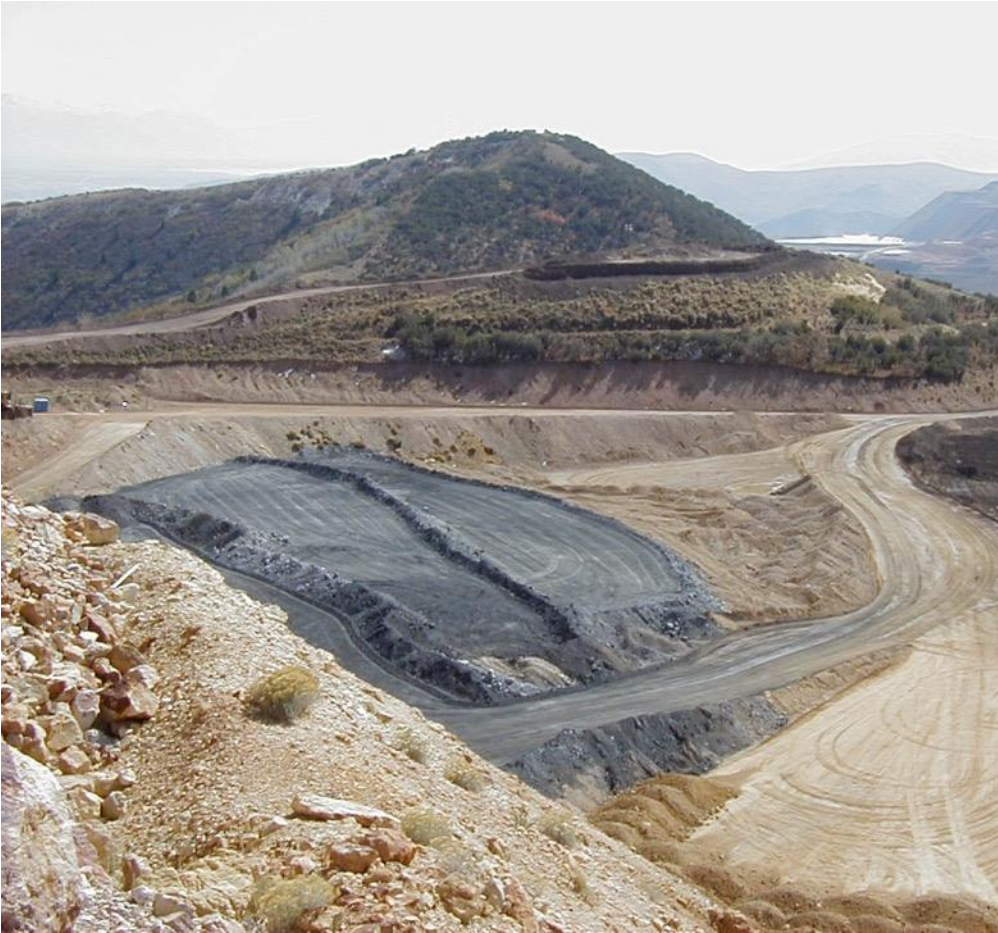
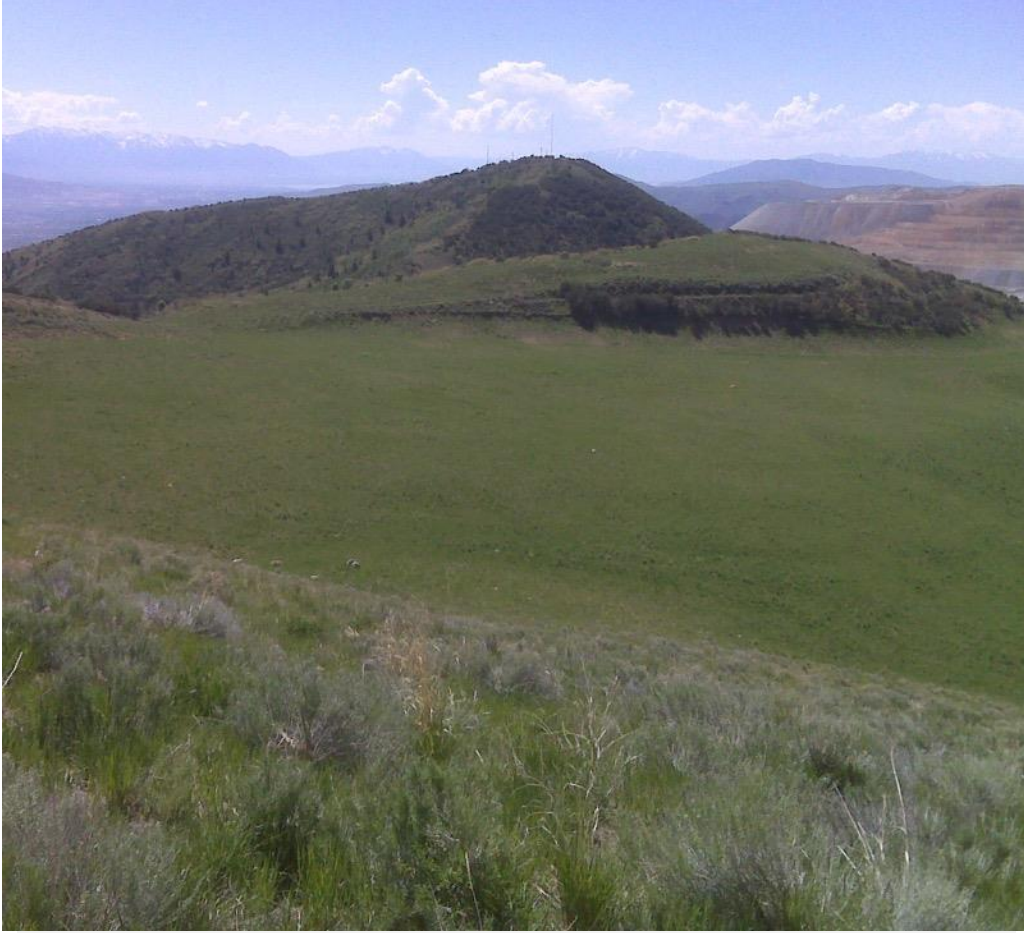
Barneys Canyon

822 acres reclaimed

Waste rock segregated and reclaimed

1995-2002

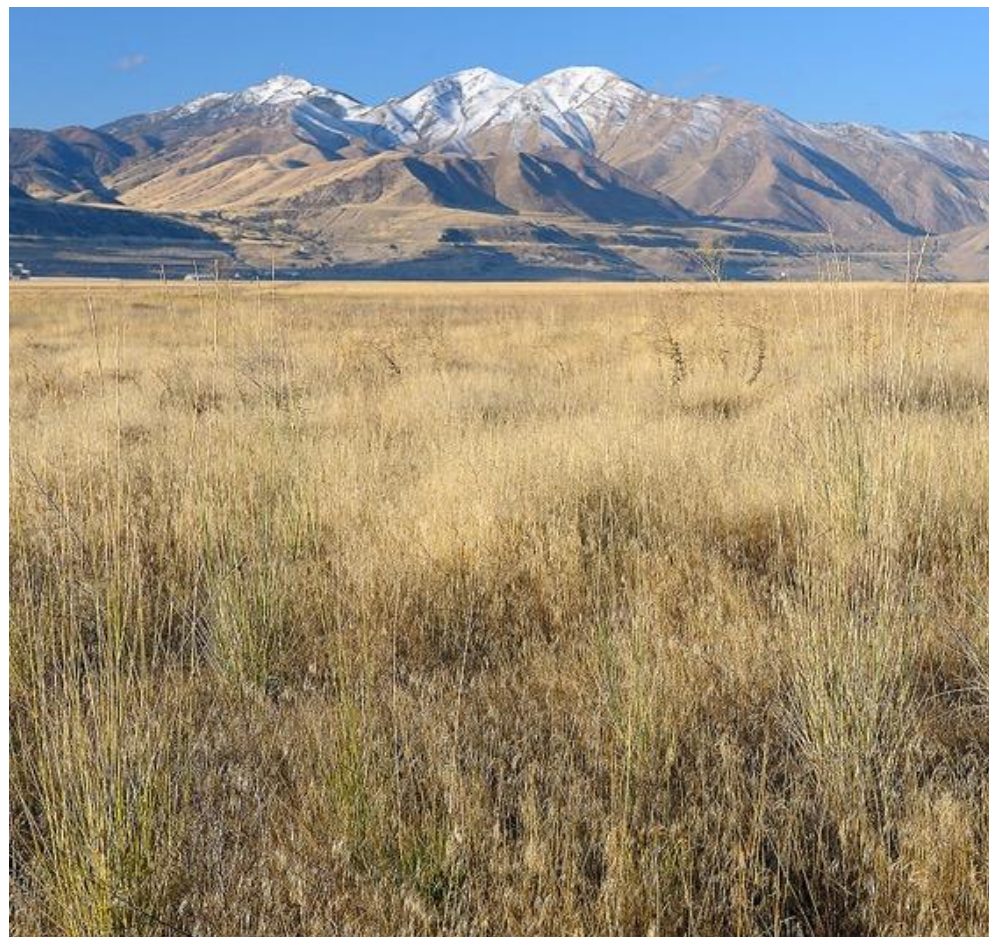
South Tailings Impoundment

3,160 acres
reclaimed
on top

1998-2002

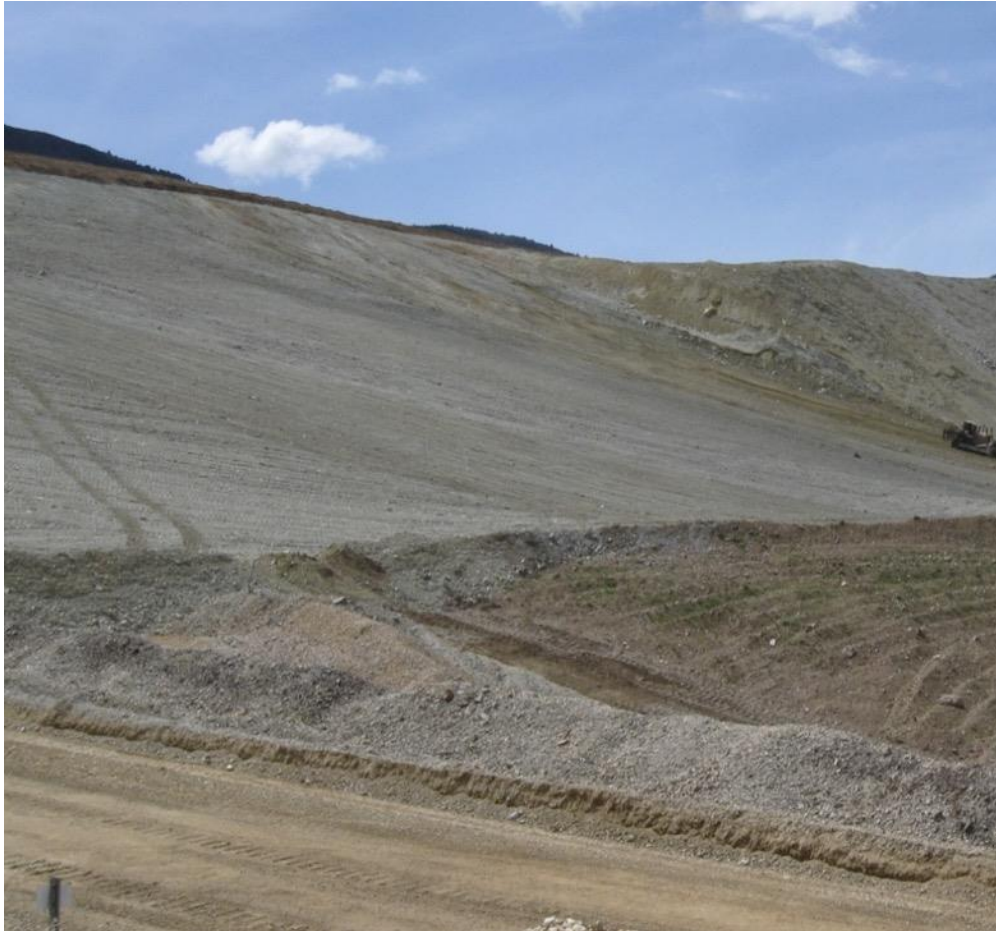
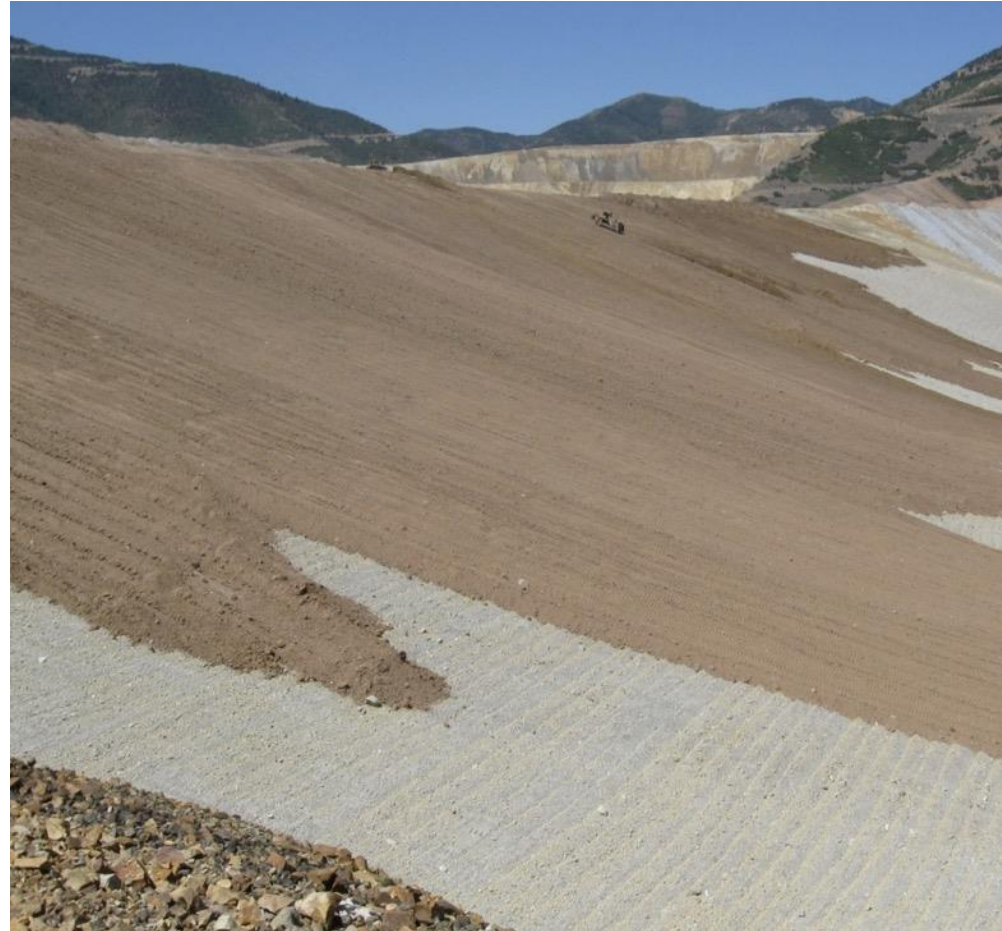
Lower Bingham Canyon

150 acres
reclaimed

Left: Relaxed slope; Right: Cross-ripping and soil; 2008-2012 dump rehab

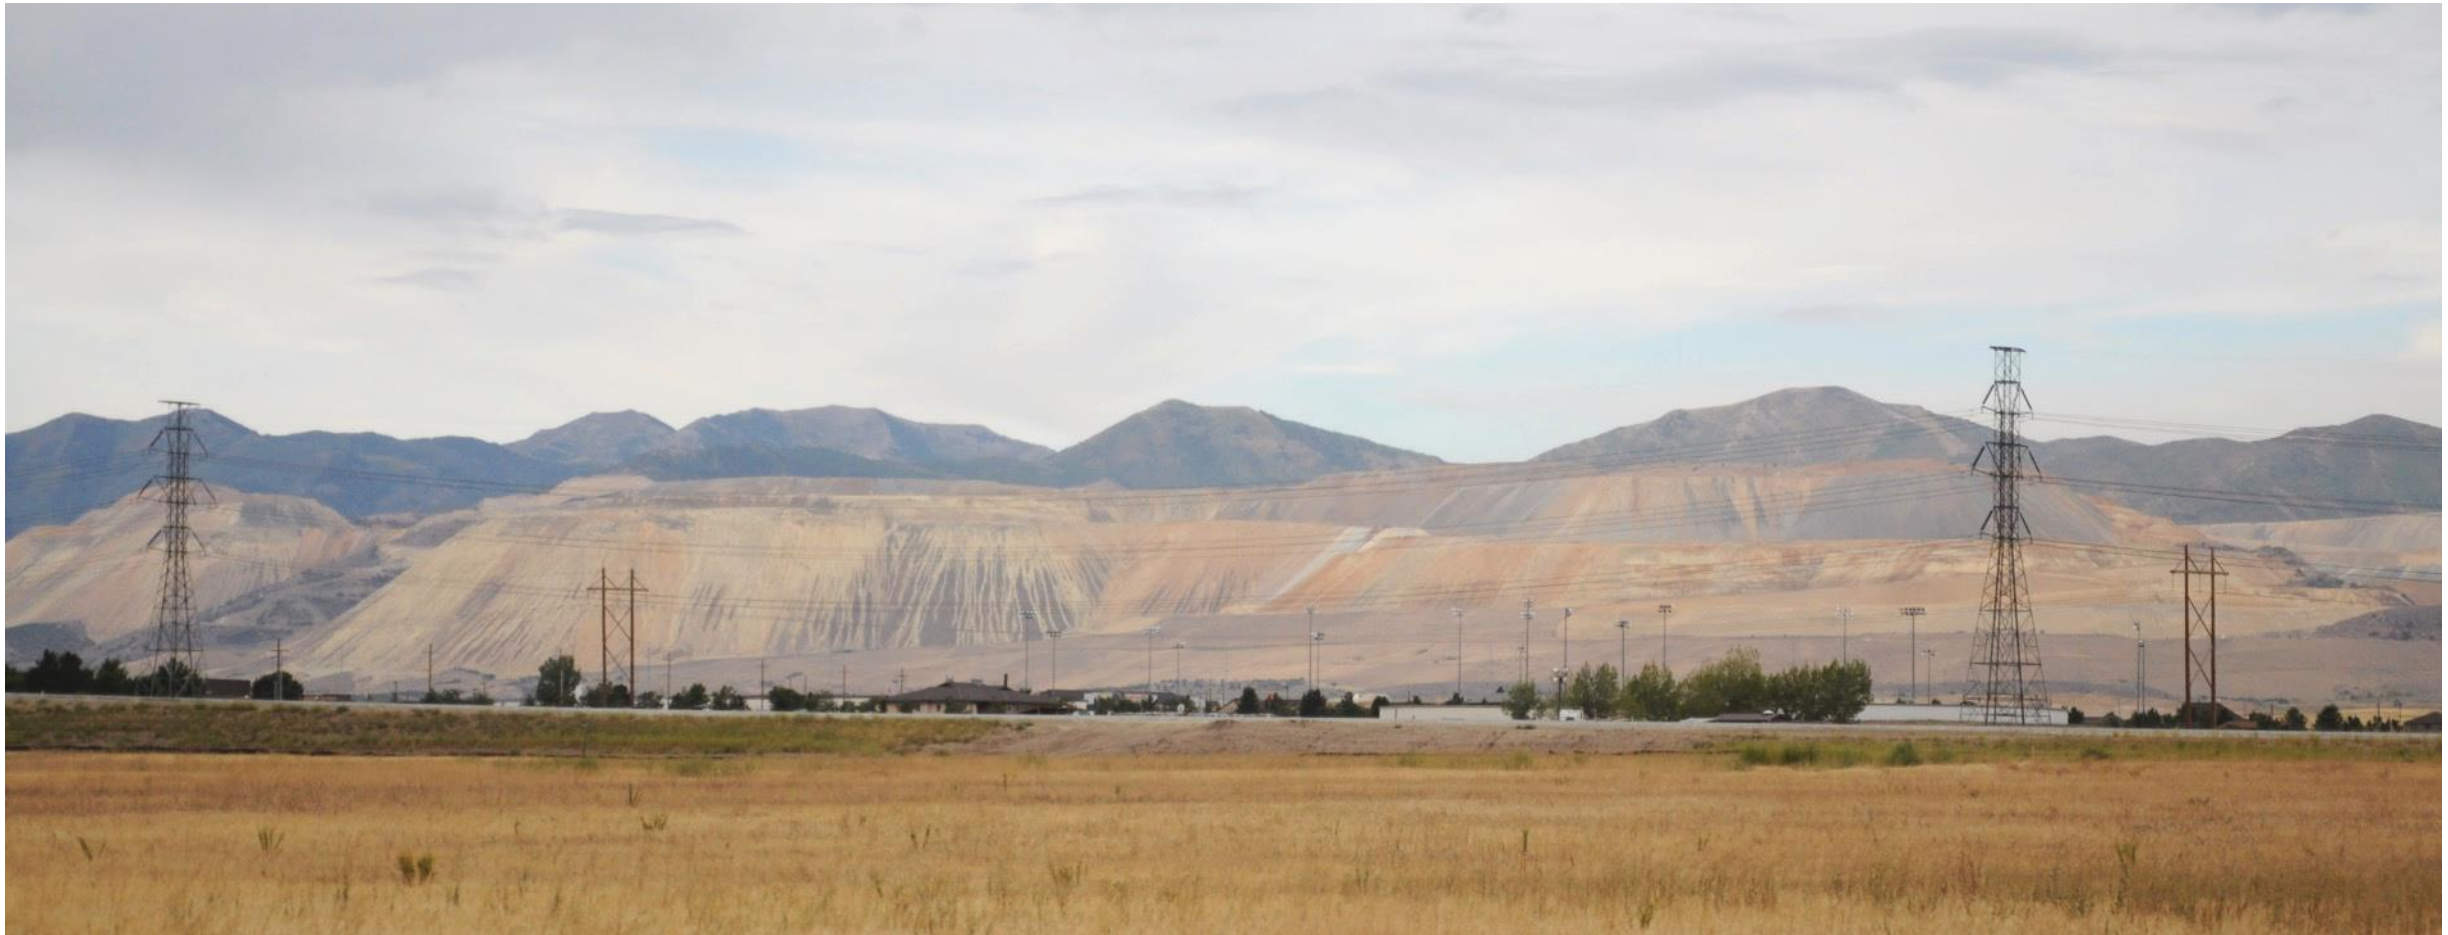
South and East Waste Rock

East-facing waste rock piles, August 2012

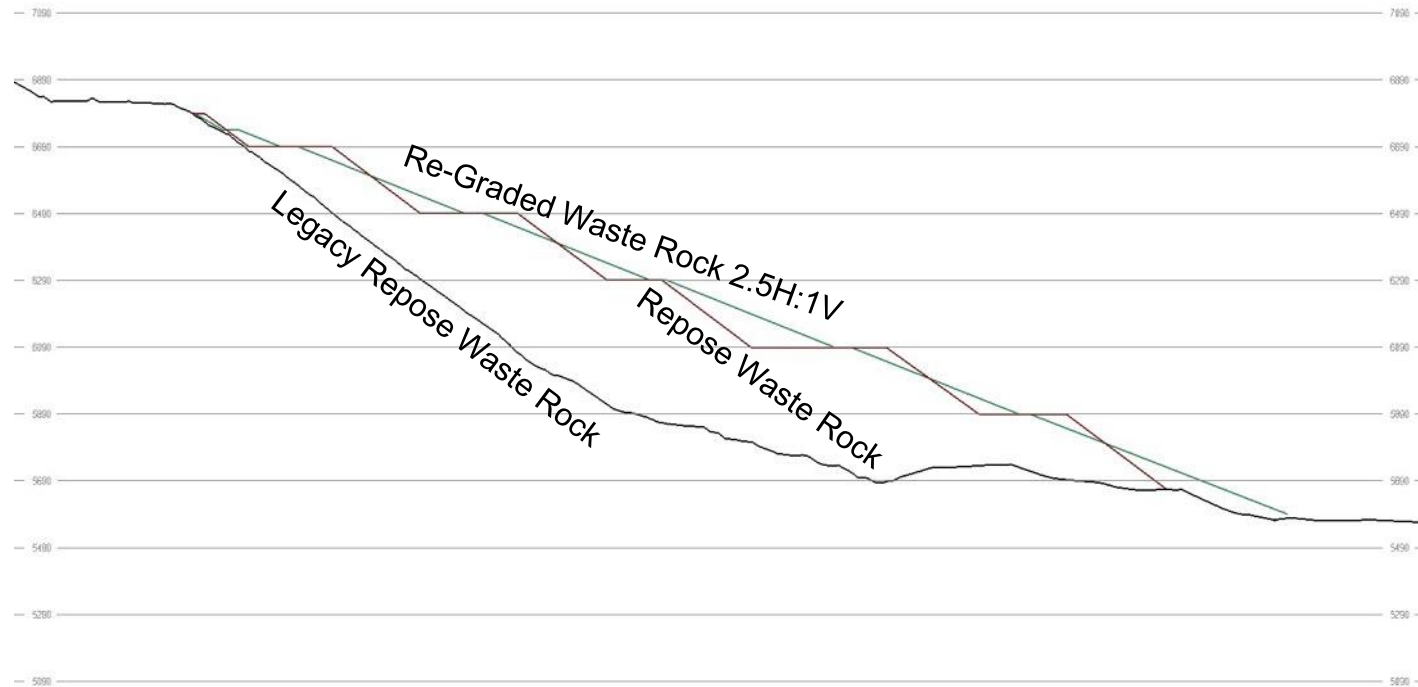
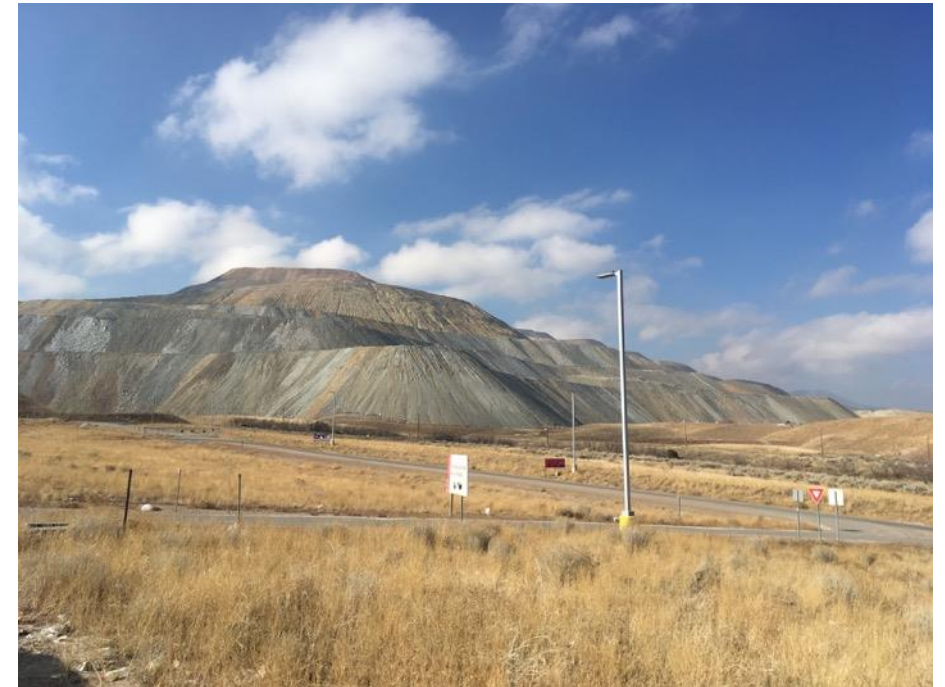
South and East Waste Rock: Legacy angle of repose

Phase I slopes regraded 2.5:1

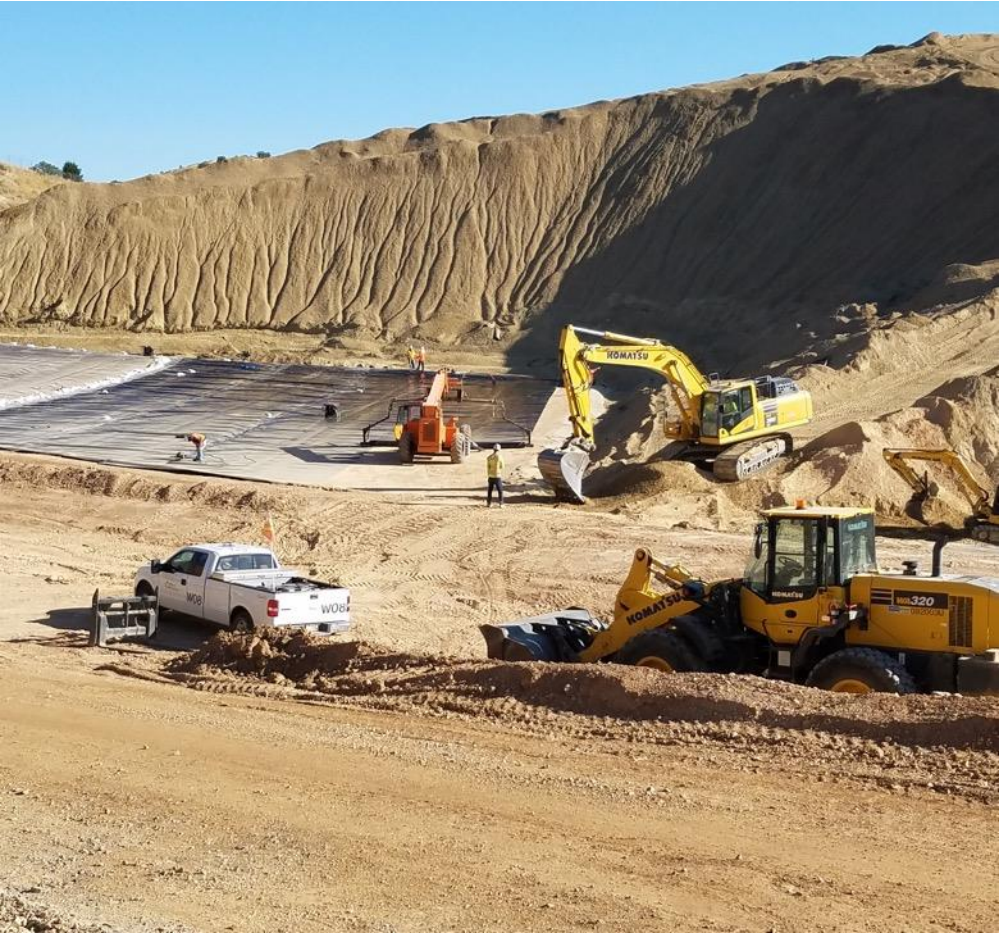
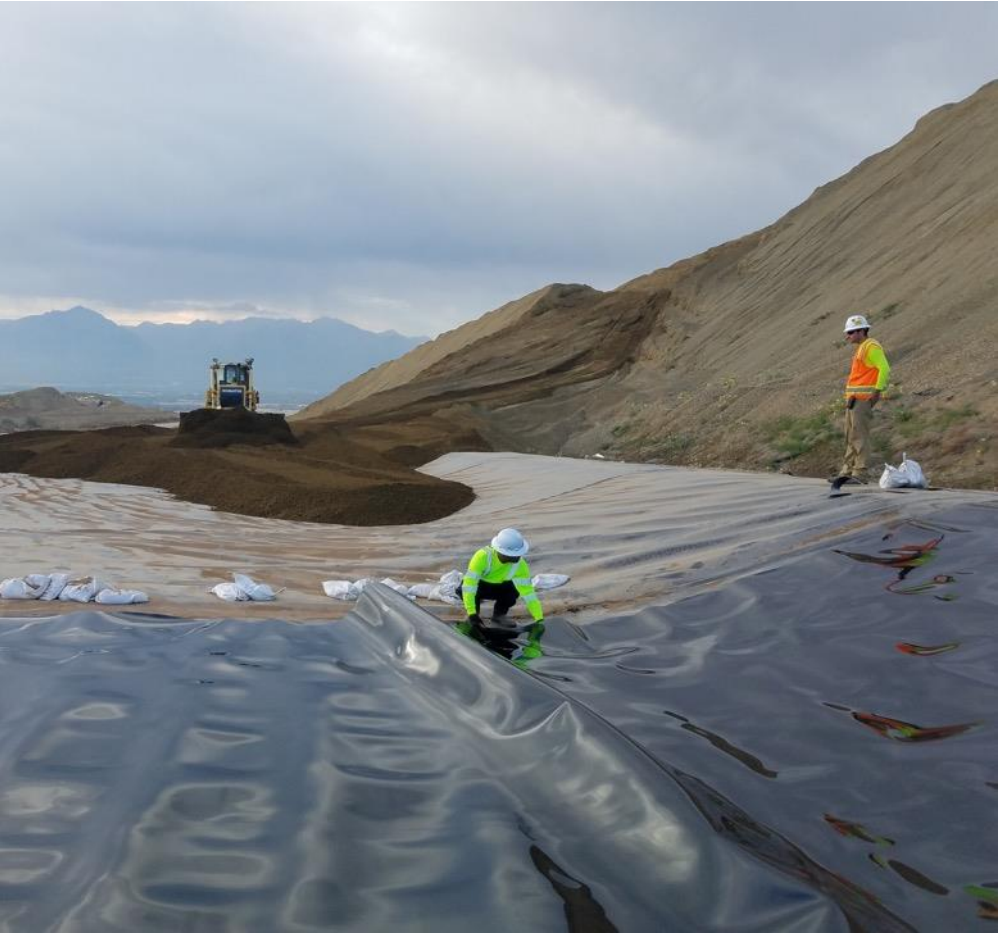
Barneys Canyon

\$2.3 million
spent in
2017

1996
